Emergency Treatment with Bistite II DC Balancing the Art, Science, and Business of Dentistry

By Jeffrey C. Hoos, DMD, FAGD

As appeared in *J. Morita's News & Views*

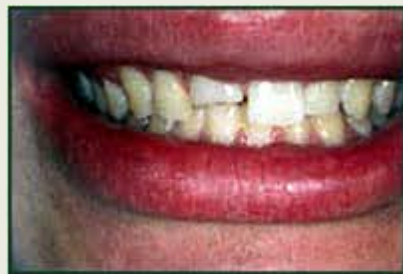
Figure 1

Many offices use an answering machine. I prefer using a very good answering service because the patient is reassured that the message is received. I received a phone call from the service at 3 pm on a Sunday. The patient was hit in the mouth during a fight and broke off his right upper central incisor (**Figure 1**). The patient was not experiencing any discomfort but was very concerned about the upcoming prom and how he would look. Fortunately the tooth piece was retrieved and kept in a plastic bag with water for hydration (**Figure 2**). If the tooth fragment had not been kept this way then the clinician would have to rehydrate the tooth.

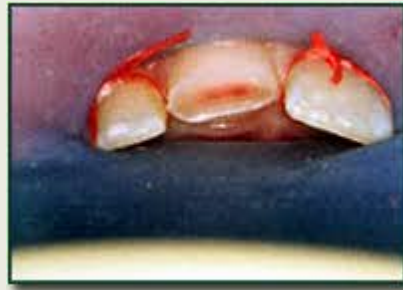
Figure 3

A rubber dam was placed around the tooth without a clamp so that no additional pressure was placed on the tooth. The pulp was exposed but there was no evidence of bleeding and the patient did not complain of any discomfort (**Figure 3**).

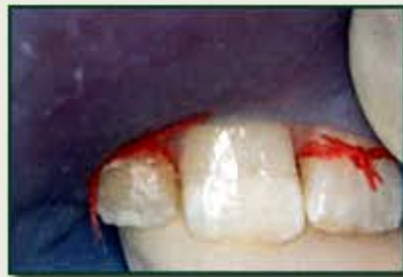
Figure 4

The piece was tested in place to assess the fit of the broken piece; the fit of the fragment was "perfect" (**Figure 4**). An articulating paper forcep was used to hold the piece of tooth because of the ease-of-use, no pressure is required to keep the piece of tooth in place (**Figure 5**).

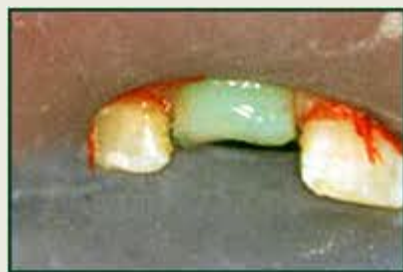
Figure 6

Acid etch was placed on the enamel surface of the tooth but none on the dentin or exposed pulp (**Figure 6**). Bistite DC is a self-etching cement but the acid was required for only on surfaces of teeth that have not been touched by a bur. The fragment was micro-etched with air abrasion and two small quarter-round bur holes were placed for additional retention (**Figure 7**). The fragment and the tooth were treated with the Bistite II DC primers for conditioning the tooth to receive the cement (**Figure 8**).

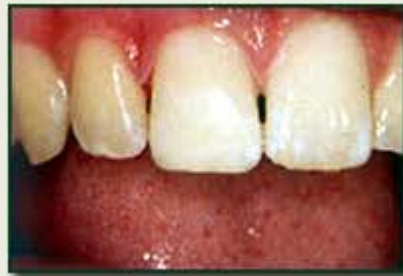
Figure 9

The fragment was moved into place with the Bistite II DC Clear cement and light cured for initial stabilization (**Figure 9**). The tooth fragment was restored in proper position with a wonderful cosmetic result (**Figure 10**). Note the lack of a cement line. The fragment has been in place for 4 years and the tooth shows no x-ray pathology or symptoms.
